I-35W Mississippi river bridge failure – Is it a wake up call?

N. Subramanian

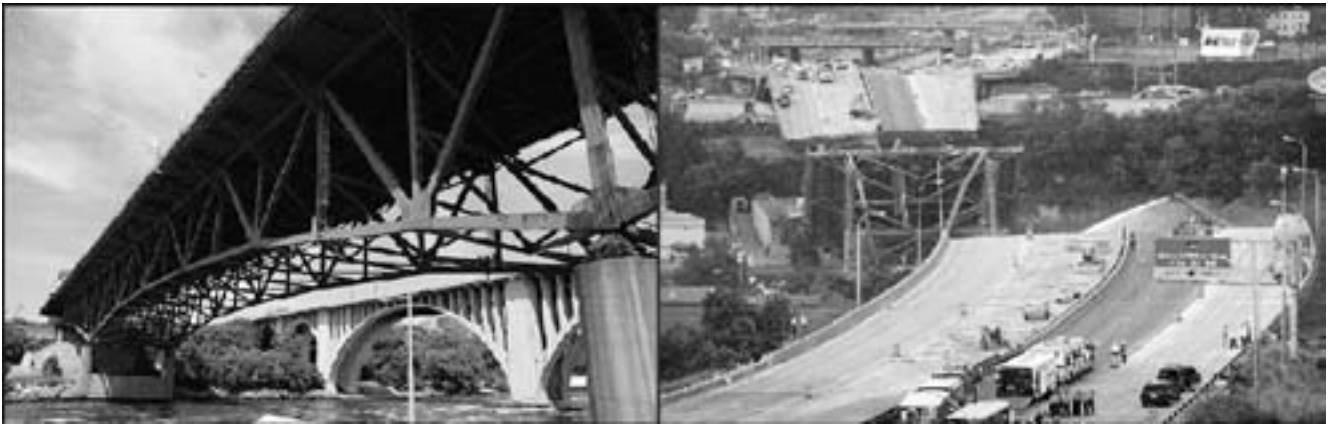
Figure 1. The I-35W Mississippi river bridge - Before and after failure

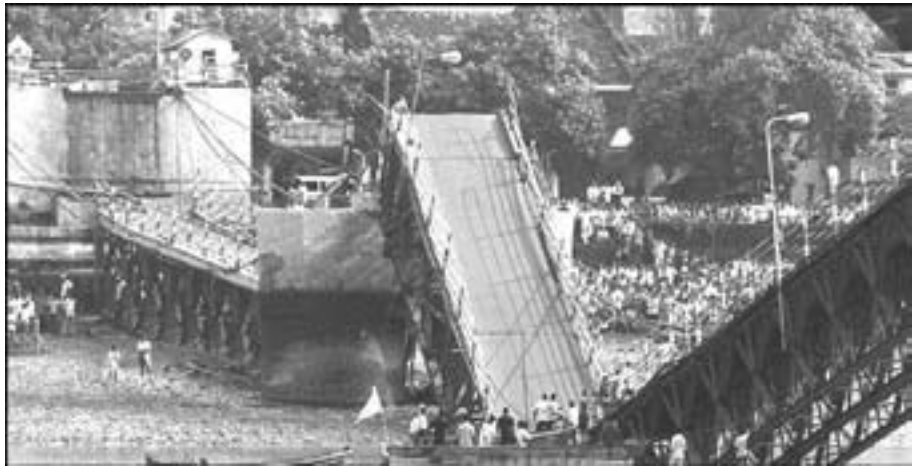
Figure 5. Bridge in Daman, India 2003

The concrete bridge in the western coastal area of Daman, about 120 miles north of Mumbai, India, collapsed, sending a school van, two rickshaws and motorcycles plunging into the muddy river. At least 25 people, including 23 children, died. After the public outrage that followed, the bridge was rebuilt by the National Building Construction Corporation, a government body, at a cost of more than Rs. 10 crore. Barely one and a half

months after its construction, the bridge collapsed again in August 2004 due to heavy floods!

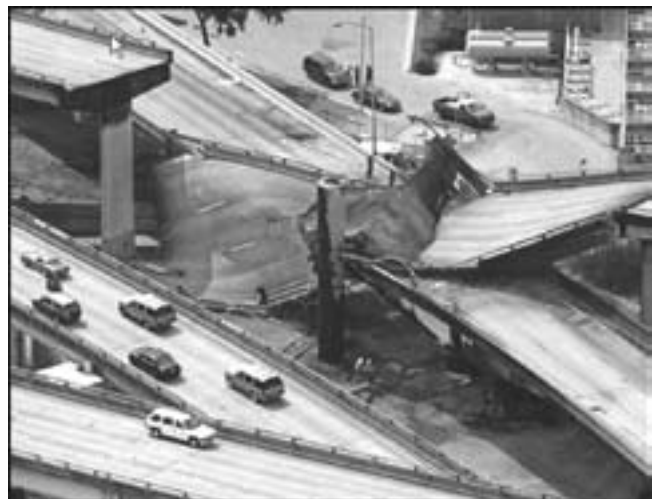
Figure 6. The San Francisco - Oakland Bay Bridge in Oakland, California, 2007

The San Francisco - Oakland bay bridge collapsed onto another highway ramp in Oakland, California, April 29, 2007, after a gasoline tanker truck overturned and caught fire.
